Assessment of Remote Cavitation Detection Methods with Flow Visualization in a Full Scale Francis Turbine

¹Xavier Escaler*; ²Ingrid K Vilberg; ³Jarle V Ekanger; ³Hakon H Francke; ³Morten Kjeldsen

¹*Universitat Politècnica de Catalunya, Barcelona, Spain;* ²*Norwegian University of Science and Technology, Trondheim, Norway;* ³*Flow Design Bureau AS, Stavanger, Norway*

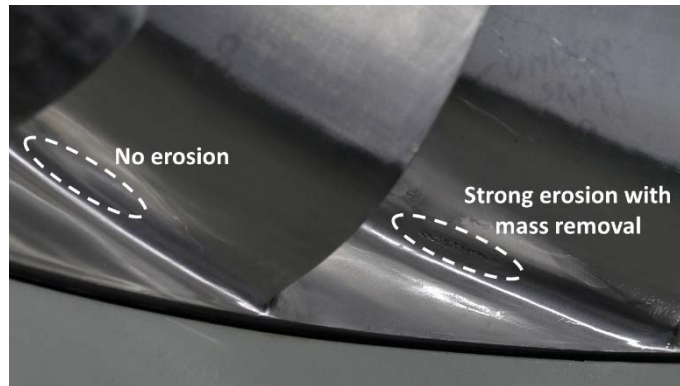
This machine is of interest because it suffers aggressive erosion on the suction side of the runner blades close to the trailing edge as it can be seen in the photograph presented in figure 1. This type of erosion is caused by cloud cavitation detaching from the blade leading edge [1]. The methods used to predict cavitation are based on induced high frequency vibrations and acoustic emissions measured on the turbine guide bearing and the guide vanes [2].

Figure 1. Photograph of the runner showing one blade with erosion and the contiguous one without erosion.

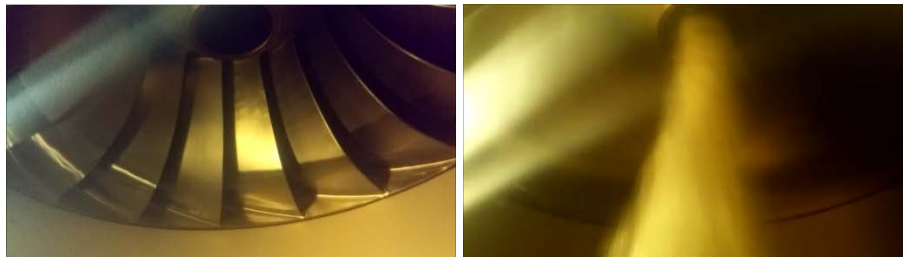
As it could be detected in a series of preliminary tests, the axis of the draft tube presents a gas-filled core for all the operation conditions as shown on the right of figure 3. The size of this cavitating vortex grows as the unit operates far from the BEP and obviously blocks the vision of the runner. Consequently, the camera had to be pointed away from the draft-tube center and given the current window positions the visible runner blades were observed when passing in front of the spiral casing end.

Figure 3. Vision of the runner from the manhole with the machine stopped (a) and with the machine operating at 19 MW (b).

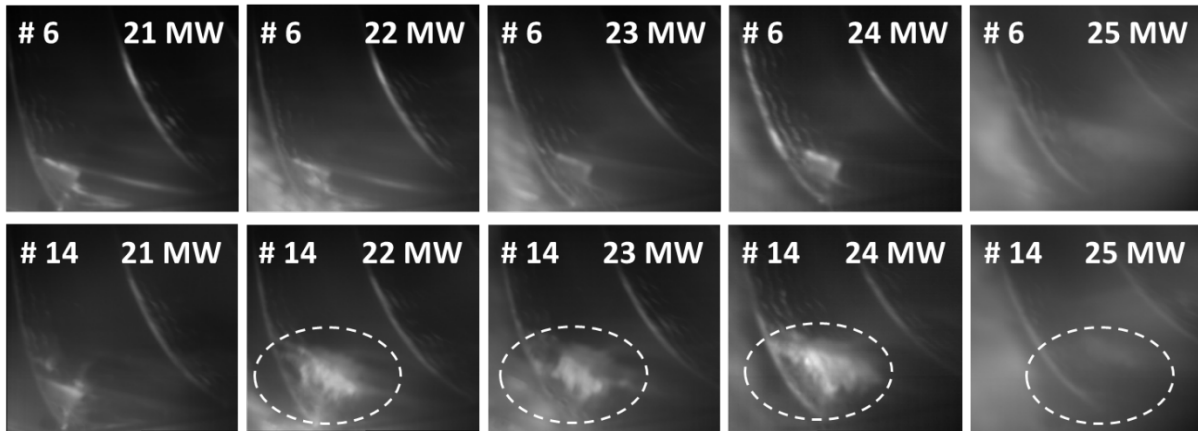
After analyzing the video records and identifying the 15 blades, it has been possible to compare their cavitation conditions among them for all the operation conditions. As it can be seen in figure 5, not all the blades present suction side cloud cavitation. For instance, blade number 6 appears not to suffer cavitation at all for any power output. On the contrary, blade number 14 is free of cavitation at BEP but develops cavitation for the rest of higher output loads. The global results regarding the presence of cloud cavitation for all the blades and operation conditions are summarized in table 1. Here it must be reminded that the field of view only corresponds to a narrow zone located next to the end of the spiral casing and no information about the evolution of the cavitation conditions as the runner blades span the whole circumference is available.

Firstly, it can be noted that only blade number 10 shows cavitation for all the loads including the BEP (21 MW). Then, cavitation starts at 22 MW for blades number 5, 13 and 14. At 24 MW, blades number 4, 6, 11 and 12 do not show cavitation yet. Operation condition at full load (25 MW) requires a special comment. Due to the significant increase of bubbles inside the flow, all the images appear excessively blurry and it is not possible to identify the presence of any type of large scale cavities. This unexpected behavior might be due to a deficient turbine setting point that reduces the available Net Positive Head (NPSHA) especially at full load.

Figure 5. Flow visualization on blades number 6 (upper row) and number 14 (lower row) for operation conditions ranging from 21 MW up to full load at 25 MW. Suction side blade cavitation is observed for blade number 14 starting at 22 MW meanwhile blade number 6 does not exhibit cavitation at any operation condition.

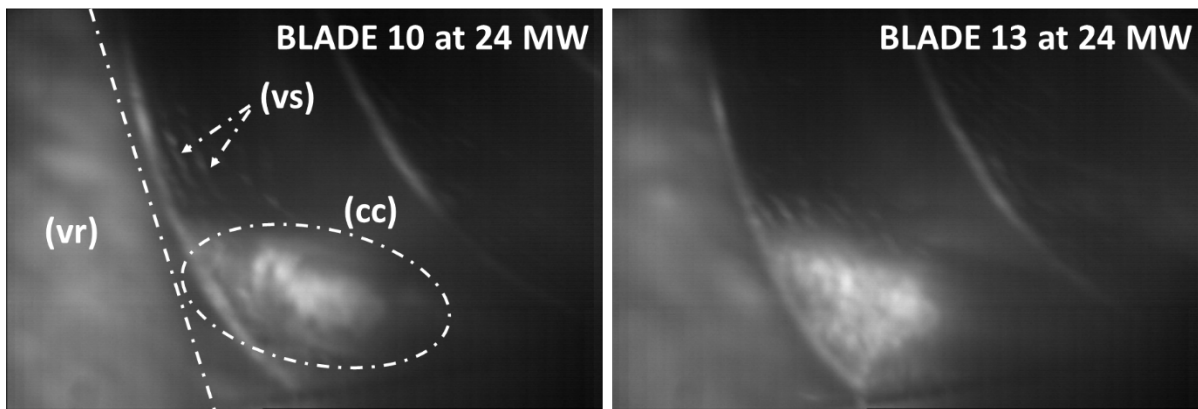
A more detailed observation of the flow field at 24 MW shown in figure 6 permits to clearly see the large-scale types of cavitation taking place when blades number 10 and 13 pass in front of the vision angle. As already commented, the closure region of the cloud cavitation on the blade suction side is observed as well as other forms of cavitation such as vortex shedding cavitation at the blade trailing edge and draft tube vortex rope cavitation from the runner hub.

Figure 6. Zoomed view of the flow field at 24 MW when blades 10 (left) and 13 (right) pass in front of the vision angle that permits to identify cloud cavitation on the blade suction side (cc), vortex shedding cavitation at the blade trailing edge (vs) and draft tube vortex rope cavitation from the runner hub (vr).

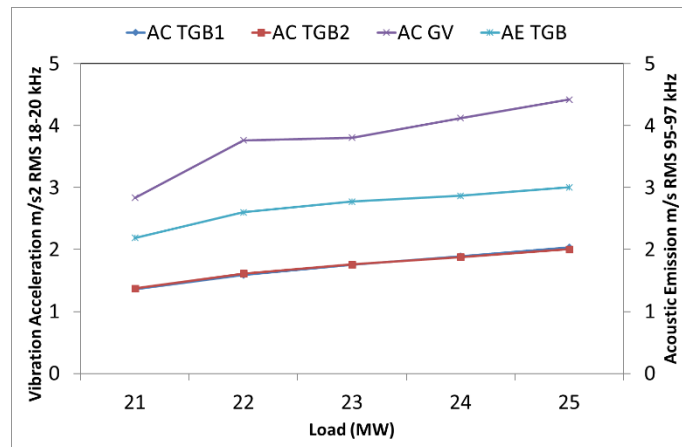
The overall RMS vibration acceleration and acoustic emission levels in the frequency bands from 18k to 20k Hz and from 95k to 97k Hz, respectively, have been plotted as a function of output load in figure 7. These results correspond to the average values from measurements taken in two different days. The data show that the levels increase with output load which corresponds to the increase of the number of blades with cavitation and the cavity sizes. The values in both guide bearing accelerometers are quite similar meanwhile the values in the guide vane are higher. The trends

from the two accelerometers and the acoustic emission sensor located on the guide bearing are analogous but the trend observed in the guide vane accelerometer differs slightly.

Figure 7. Overall RMS vibration acceleration and acoustic emission levels in the frequency bands [18k-20k Hz] and [95k-97k Hz] respectively, as a function of output load.
